**Barry Ash Pond Review  
Barry Power Generating Facility  
Mobile, Alabama**

**Mobile Baykeeper**

March 23, 2018

**Burgess Environmental**

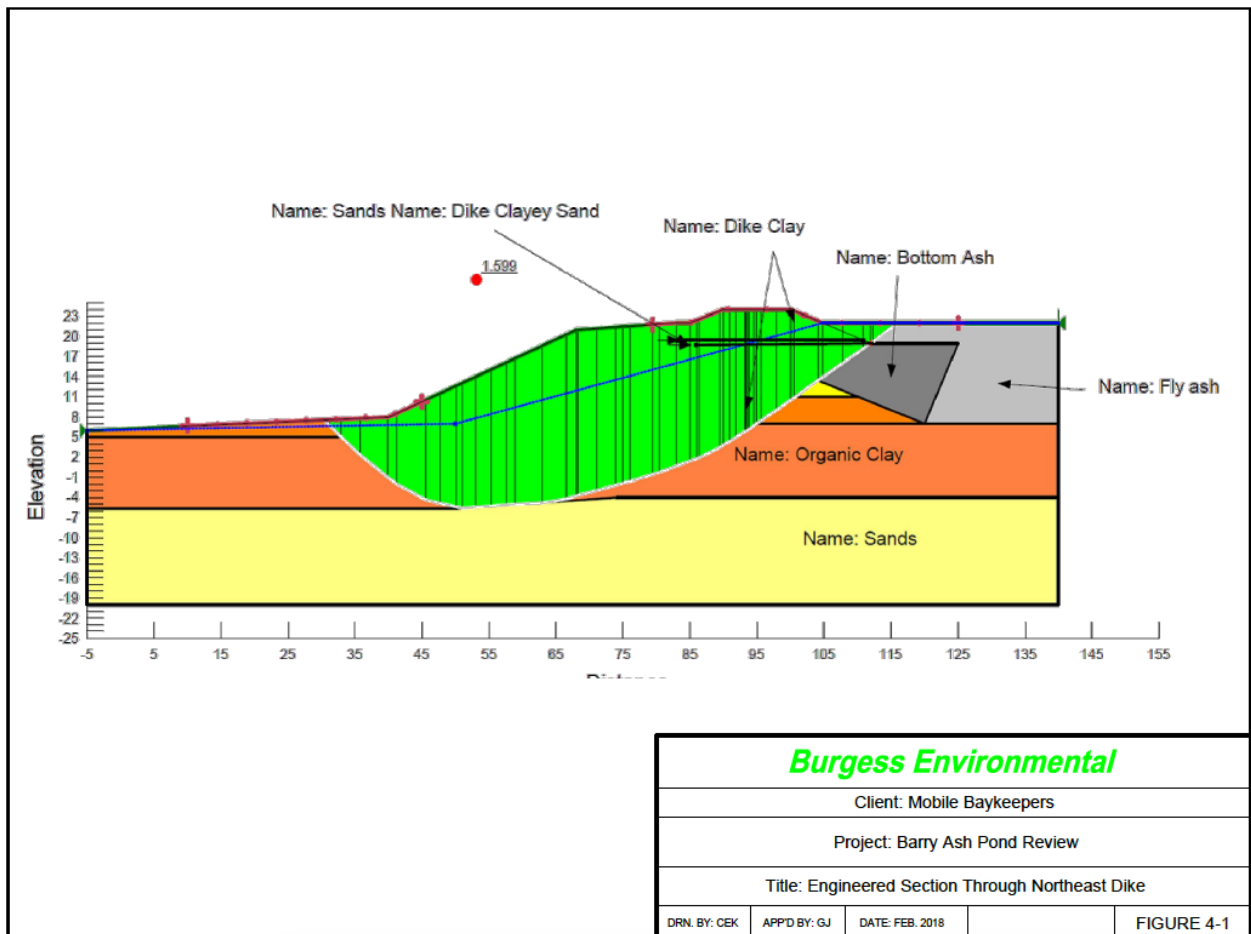
**Figure 4-1**  
**Engineering Section Through Northeast Dike**

that were obtained from previous reports. The stability analyses were completed for the 'critical section' along the northeast main dike, although the criteria used to establish the critical section was not explained. Liquefaction analysis was not completed because the dikes were determined by Pegues as not susceptible to liquefaction. It is standard practice to consider this potential mode and liquefaction analysis should have been completed for the Barry Pond. In particular, liquefaction analysis should have been completed for the dikes that are founded on ash and sand that could be susceptible liquefaction.

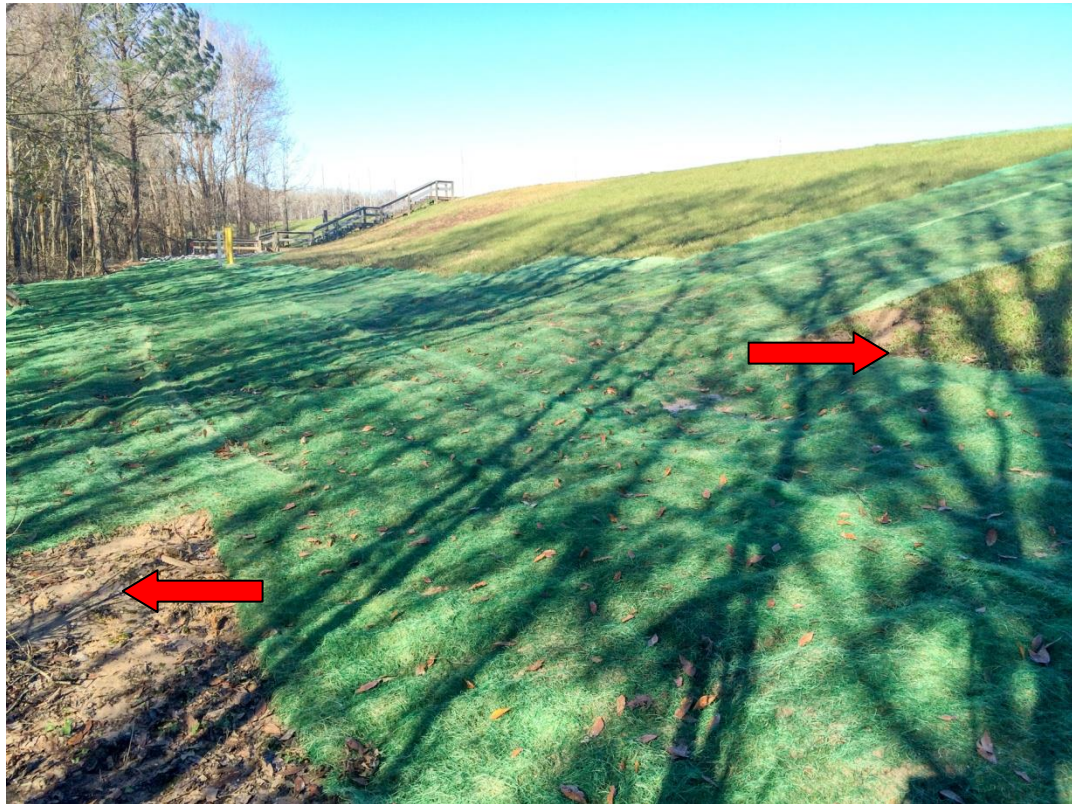
Potential for piping was observed during the site visit completed on February 9, 2018, from a backwater that is located immediately upstream of the outlet structure. A bulge in the toe of the slope is evident at this location, as are slope repairs and accumulation of sand at the toe of the slope. These observations corroborate observations made and pictures taken by Baykeeper staff on February 4, 2016 (see Photos 1 and 2). Evidence of piping can be seen in the slope above and below areas of the slope where sod was placed as part of a slope repair. A short video taken that same day clearly shows seepage flowing out of the toe of the dike, resulting in erosion of the toe.

**Photo 1: Evidence of Piping North of Pond Outlet (Feb. 4, 2016)**

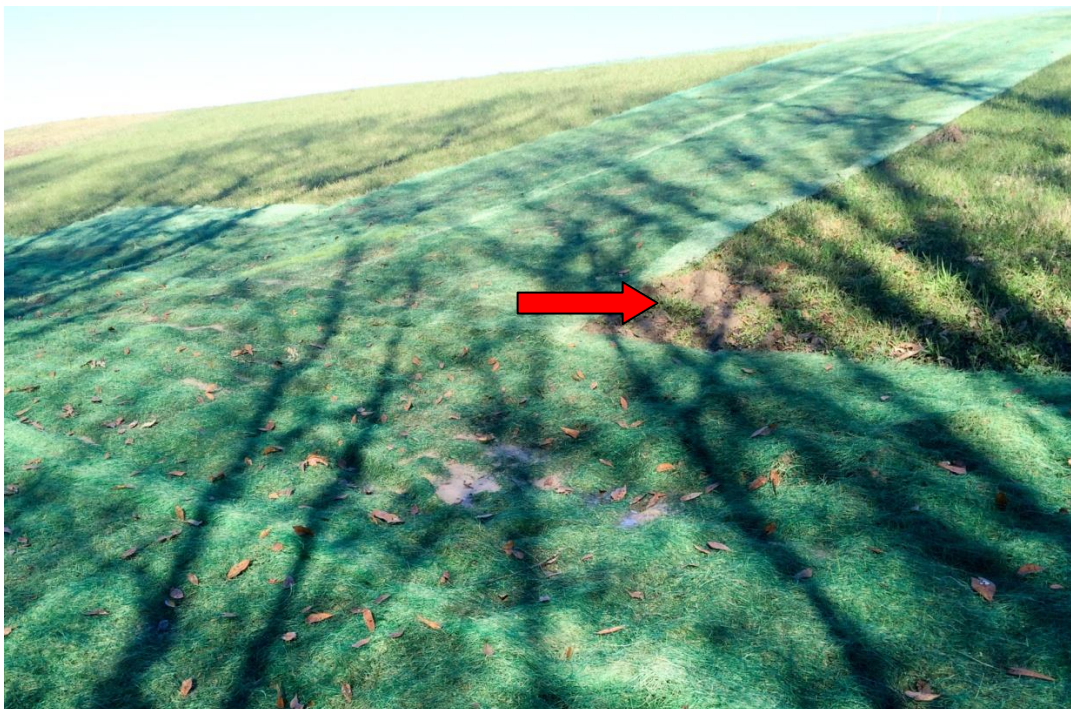
**Photo 2: Evidence of Piping North of Pond Outlet (Feb. 4, 2016)**
